The Wallasey Embankment

M. N. BELL, BSc, FICE*

The Paper traces the concept and history of the Wallasey Embankment from its origin in the early 19th century when coast erosion on the Wirral and the development of the port of Liverpool made its construction necessary. Subsequent maintenance methods and improvements to the structure, which were developed in the face of increasingly rigorous exposure conditions experienced since the original construction, are described. An account is given of emergency procedures adopted when the integrity of the embankment has been put in jeopardy by severe storm damage. Emphasis is placed upon the desirability in a structure of this type, of exposed elements being designed so as to control the spread of storm damage and to permit permanent repairs and replacements to be executed rapidly using readily available resources. The current reconstruction programme and methods which have been developed to this end are described in detail, including modifications to accommodate difficult ground conditions and improved construction techniques. Finally the principles of the design and construction are considered in the general context of protective structure

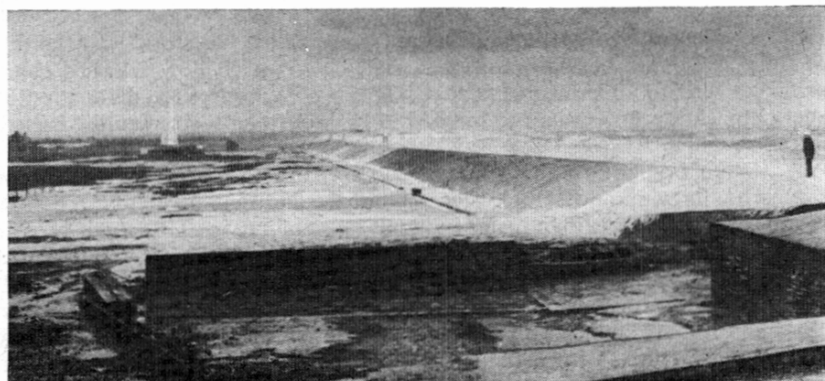
Fig. 6. Overtopping of embankment during NW gale, 2 April, 1973

12. The increased depth of water over the lowered foreshore has allowed the incidence of larger waves (Fig. 6). To reduce overtopping, therefore, a raised crest was added to the original embankment and more recently, to effect virtual elimination of overtopping, a wave-return wall has become necessary. With regard to the profile prior to the present reconstruction, model tests conducted at the Hydraulics Research Station in 1969³ at the request of the Mersey and Weaver River Authority suggested that if the 1 in 100 year tidal level were associated with the highest yearly wave, with a 9 s period, the rate of overtopping would be of the order of 65 m³/h per m run of embankment. If this overtopping rate were combined with a fresh water flood discharge, the capacity of the River Birket, which drains the adjacent low ground, could be exceeded. The model tests further showed that a 0.9 m high curved wave wall at a fixed level constructed along the crest of the embankment could almost eliminate overtopping at the 100 year tidal level.

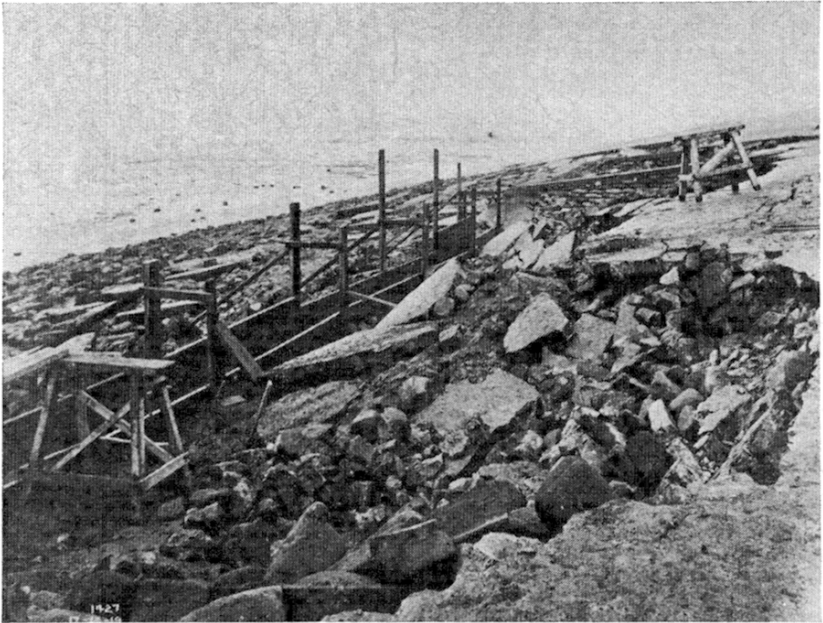
15. Records of severe storms in 1883 and 1919 have been found, including photographs which show that the structure suffered severe damage. Certainly in the latter instance the embankment was threatened with a breach (Fig. 7). The affected area was eventually contained and stabilized by constructing an irregular network of massive concrete walls, within which it was possible to replace the heart and reconstruct the facing. Between 1955 and 1970, as a consequence of a reduced level of maintenance work, there were several severe breaks, the largest of which involved partial dislocation of the eastern corner, although a breach of the embankment was averted. Repairs during this period took the form of hardcore infill and mass concrete slabbing.

Fig. 7. Storm damage incurred during December 1919 showing cut-offs walls under construction

beach lowering. To stabilize the repaired toe and prevent recurrence of washout, a toe wall was constructed in front of each break, which was then sealed with clay, pitched sandstone blocks and concrete. The toe wall was up to 3 m deep, being carried down 0.5 m into the boulder clay where found, and was eventually constructed along most of the toe of the embankment. An apparent random alignment of toe wall sections is somewhat perplexing; one possible explanation is that the fixing of the toe wall shutter in a damaged area was dependent on the location of the landward face of the break. There appears not to have been any major modification to this approach up to 1941, by which time some 85% of the structure had been protected with a toe wall to secure the original sandstone paving.

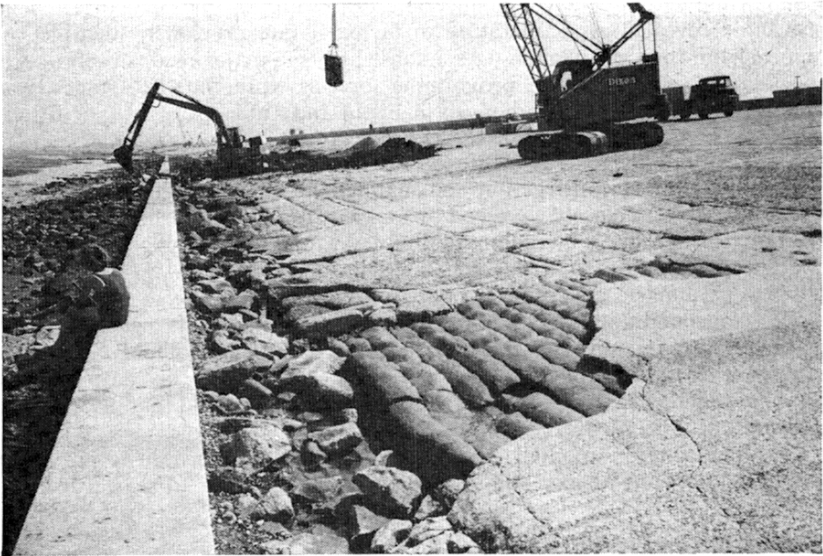
Fig. 9. Deteriorated facing prior to reconstruction, 1974: new precast toe beam in position

damage. However, the facing panels laid at this time in the tidal zone were only about 0.15 m thick, and a concrete of relatively low durability was used (Fig. 9). Also, due to the haunched cross-section of the cell cut-off walls providing peripheral bearing, the infill slabs were subject to undetected undermining, leading eventually to sudden collapse. A large amount of reconstruction was subsequently undertaken and all 'breaks' sustained up to 1957 were reinstated using this method. Only a small length of new toe wall was constructed during this period, although the existing wall was maintained.

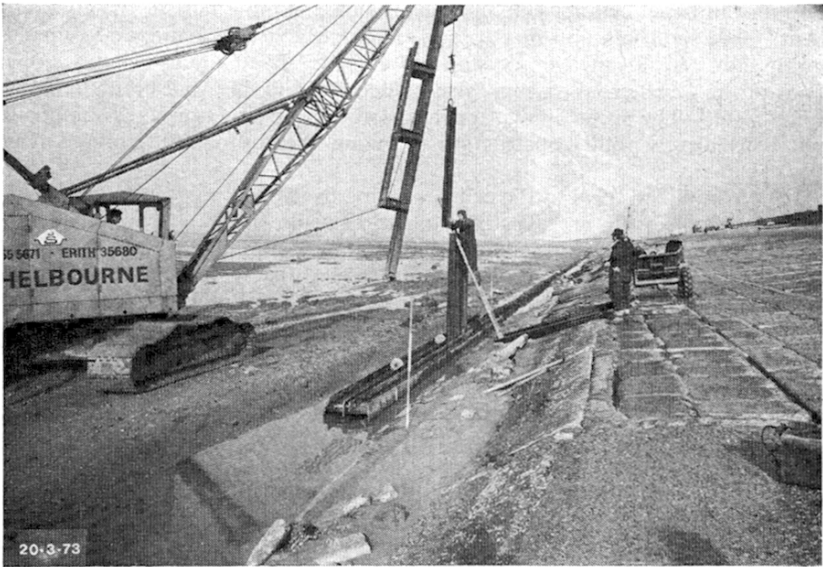
Fig. 10. New toe sheet piling being driven to seaward of old toe construction

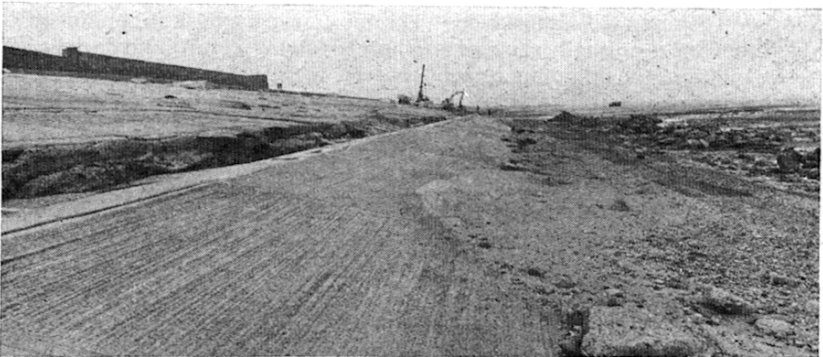
Fig. 11. New toe construction completed before start of facing reconstruction, showing sand accretion

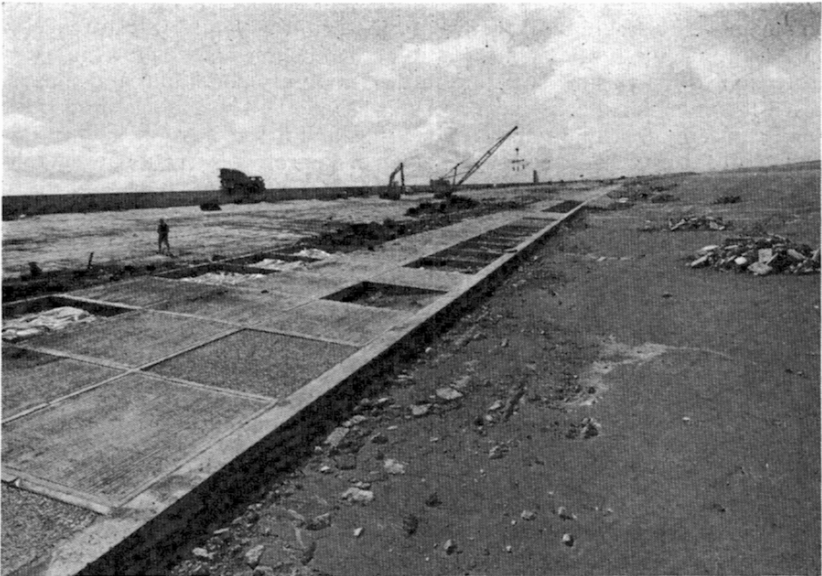
Fig. 12. Reconstruction stage I facing under construction showing some unfilled cells in temporarily stable condition (the infill concrete in one of the bottom-row cells has been damaged by sea action and was replaced in due course)

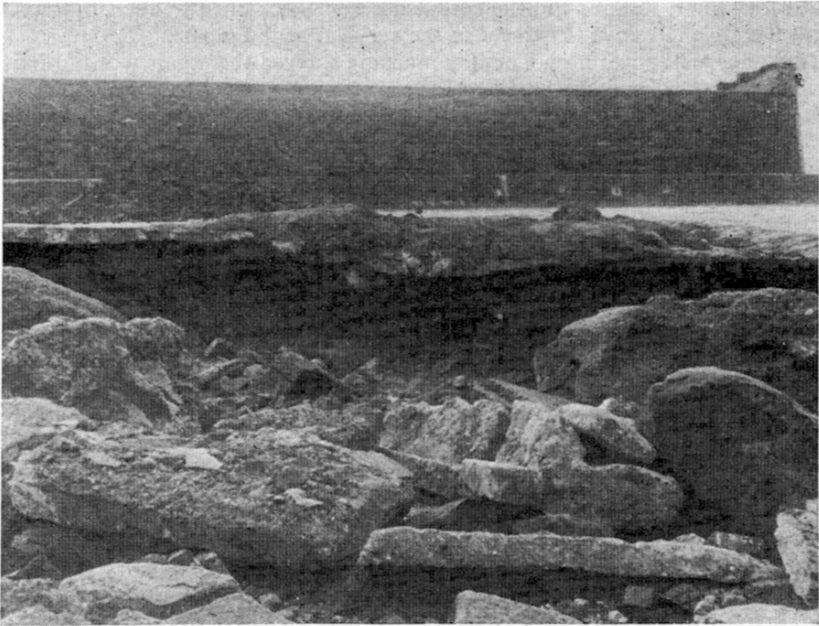
44. On one occasion both adverse conditions described in § 39 occurred at their most extreme, and their combined effect led to the development of the most dangerous threat to the integrity of the structure since the major break of 1919 (Fig. 15).

Fig. 15. Part of the deep break in November 1973 showing old 'non-tidal' facing concrete undercut by wave action

At an inspection at 1600 h on a Sunday afternoon in November 1973, after three successive tides of 8.8 m above chart datum (Liverpool Bay datum), with a following NW wind of force 7-9, it was discovered that an area of the existing structure approximately 90 m² adjacent to incomplete new works, had begun to break up. A labour force was recruited, but only backfilling of the area with clay was possible at this time.

46. The affected area was known to be protected by a continuous mass concrete skin 150-200 mm thick extending from the working area to the crest of the structure, with no apparent cut-off walls. What had not been realised until the tide exposed the edge of the area was that here the underlying clay was absent and the formation consisted of brick hardcore and demolition rubble.

47. Inspection after the night tide showed that the clay fill had been removed and the break up of the area had extended. The Contractor mounted a major repair operation for the Monday afternoon. Meanwhile the morning tide accelerated the deterioration. The area had now extended to 600 m² with a depth on the landward face of 3 m below adjacent paving level, constituting a major break with definite breach potential. The Contractor's repair effort was plagued with almost impossible working conditions (driving hail and sleet, in force 10 winds), and due to the poor formation and the extent of its exposure his access was severely hampered. The technique adopted was a general backfilling with available material and protection with an in situ concrete cover. The extreme ambient conditions, together with the increased

48. Inspection early on Tuesday morning showed the repair work to have been obliterated and the break to have worsened to such an extent that the danger of losing an entire section of the structure was imminent. The area of the break was now 800 m². Temporary backfilling was undertaken before the Tuesday morning tide and 'urgent repairs' were put in hand for the Tuesday afternoon. These repairs were based on a 'terracing principle', taking advantage of the fact that a tide attempts to reduce all upstands to a horizontal condition. Thus it was hoped that if a tide-resistant bund could be established across the lower section of the break, connecting the existing structure remaining on each side, the landward side could be backfilled to the level of the bund with natural fill only and would still be resistant to tidal action. The procedure could then be repeated at successively higher levels until the break was secured with final tide-resistant sealing between the fill and the existing structure along the sides of the break. Facing the area with an in situ concrete skin could then be carried out at comparative leisure. This method had already been tried in a makeshift manner on the Monday evening with the facilities then available. On that occasion it had proved ineffective, but it was felt that the principle was sound.

49. The material chosen for the lower bund wall was standard cement-filled bags. This material was chosen for its immediate availability as well as its resistant properties. The upper bund wall comprised rejected toe beam units and the natural fill was crushed rocksand from nearby rock tunnelling contracts. Over 100 t of bagged cement were placed by hand and machine in the lower bund, which was approximately 40.0 m long and 1.5 m high, pumped sea water being used to cool the bund during all stages of construction. Over 1000 m³ of rocksand were placed behind the bund wall and three 5.0 m long toe beam units were established as the upper bund wall.

50. All this work was completed on the Tuesday evening (7 h low water period) in weather conditions as severe as those of the previous evening. Added to that, the evening tide was again over 8.8 m above chart datum and backed by a NW gale of force 9 with gusts up to force 10. Inspection on the Wednesday morning showed the scheme to have been completely successful. Some minor erosion had occurred along the edges of the break which had not been sealed the previous evening. These edges were sealed, and held during the next tide. The break was then finally protected with in situ concrete over the next two low water periods.
