The Wallasey Embankment

M. N. BELL, BSc, FICE*

The Paper traces the concept and history of the Wallasey Embankment from its origin in the early 19th century when coast erosion on the Wirral and the development of the port of Liverpool made its construction necessary. Subsequent maintenance methods and improvements to the structure, which were developed in the face of increasingly rigorous exposure conditions experienced since the original construction, are described. An account is given of emergency procedures adopted when the integrity of the embankment has been put in jeopardy by severe storm damage. Emphasis is placed upon the desirability in a structure of this type, of exposed elements being designed so as to control the spread of storm damage and to permit permanent repairs and replacements to be executed rapidly using readily available resources. The current reconstruction programme and methods which have been developed to this end are described in detail, including modifications to accommodate difficult ground conditions and improved construction techniques. Finally the principles of the design and construction are considered in the general context of protective structure

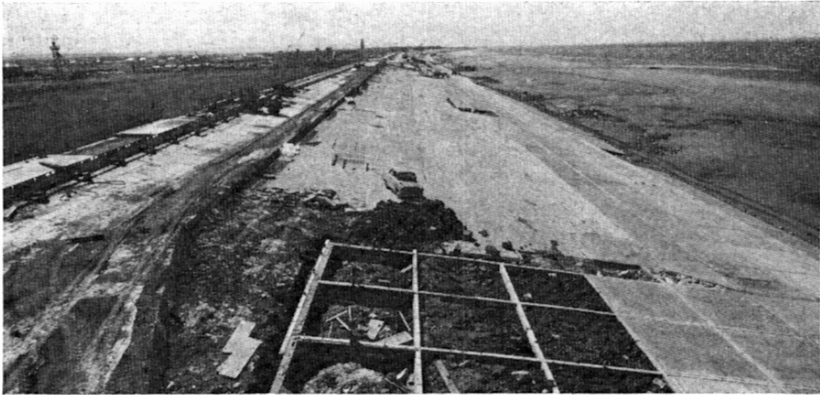
Fig. 1. General view of embankment

1. The Wallasey Embankment (Fig. 1) is a sea defence and coast protection structure, 3.6 km long and rising approximately 10 m above beach level, which was constructed during the first half of the 19th century under an Act of Parliament 'for the purpose of preventing further encroachment of the sea and the injury to arise therefrom to the contiguous lowlands and to the Port of Liverpool'. The embankment lies along the low-lying middle third of the Wirral Coast between Wallasey and Hoylake in the Metropolitan Borough of Wirral. It faces squarely into NW gales which are the principal cause of coast erosion in the Liverpool Bay sector of the Irish Sea (Fig. 2). It is the sole protection against sea-flood afforded to some 18 km² of low-lying land which has been extensively developed for industrial and residential use (Fig. 3).

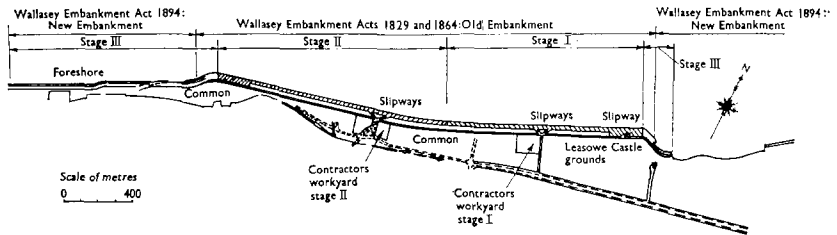
Fig. 4. Plan of embankment showing extent of each stage of the current reconstruction programme

4. Following serious erosion around the flanks of the Old Embankment the works were extended at both ends under an Act of Parliament in 1894, increasing the total length of the structure to about 3.6 km. These two extensions are known as the New Embankment (Fig. 4).

costs prompted a detailed engineering inspection of the structure. This inspection revealed an acceleration of facing failure previously identified in reports from the Consultants. As a consequence a major reconstruction was considered necessary and a programme for this work, in three stages, was initiated in 1972. Details are given in Fig. 4 and Table 4.

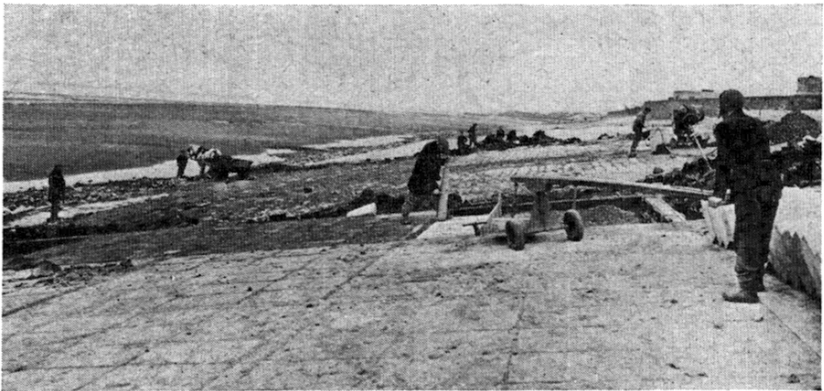
Fig. 8. Cellular paving under construction by manual method, 1949

and infill paving panels were formed in concrete, sometimes in situ and sometimes precast, reinforced and unreinforced (Fig. 8). The clay seal was usually maintained beneath the infill paving. The purpose of the cellular construction was to limit the extent of washout, upon eventual failure of the infill concrete skin, to a single bay of a size which could be made good in one tide by the maintenance gang. In general this design proved successful in containing

19. A landmark in the history of the embankment was provided by the change in facing reconstruction pattern adopted by the Mersey Docks and Harbour Board in 1941. The main outcome of this change was the adoption of cellular construction, resembling that used before mainly for major emergency repairs but using modern materials and arranged in a regular grid pattern. This development for the more exposed parts of the face took the form of a network of cells approximately 4 m square. The cell boundary walls

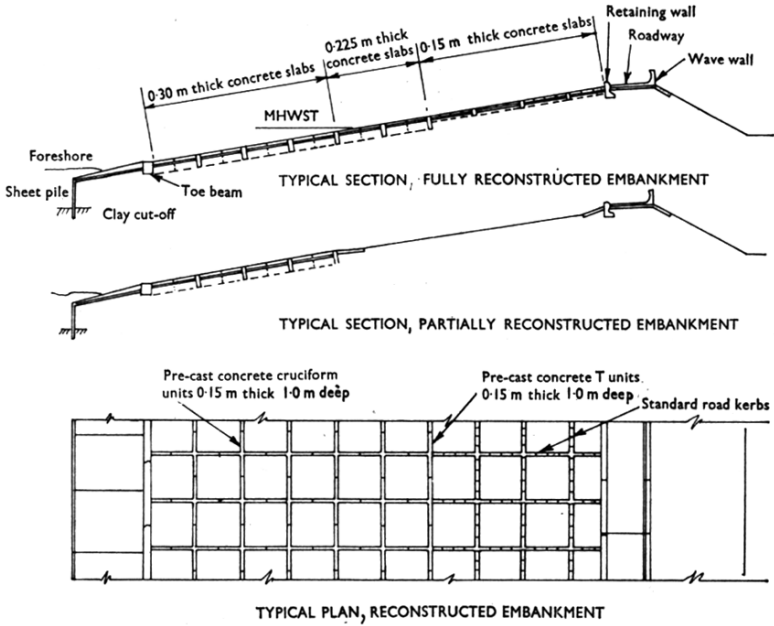
Fig. 13. Typical plan and cross-section for stage I of the reconstruction

33. In stage I (Fig. 13) the Contractor elected to precast the toe beam sections, and this method proved successful, although the weight of each unit (over 8 t) complicated handling. It was found quite practicable to store the precast sections along the foreshore before placing. When placed in position the toe beam sections, if slightly haunched with concrete to prevent base lubrication, were stable in all the sea conditions experienced and were installed prior to tidal concreting in any area. Once the toe beam was in place and

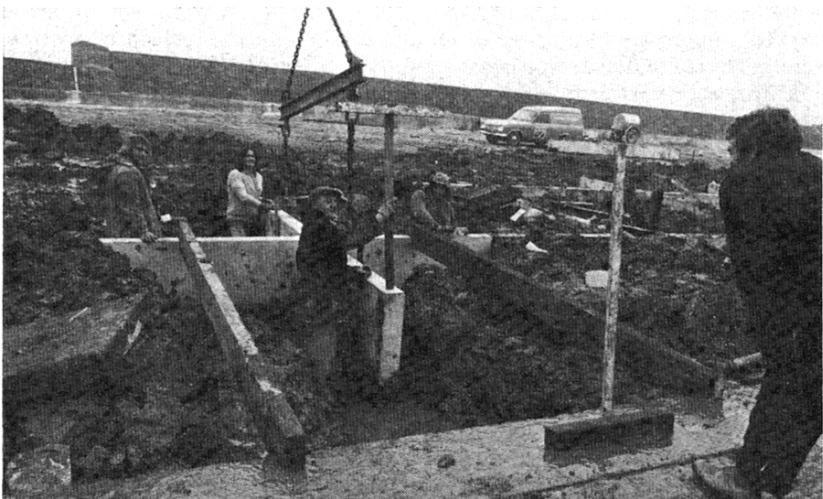
Fig. 14. Placing precast cruciform units in stage I facing

37. During the early period of the contract, installation of the cut-off units in the facing was found to be difficult, the difficulty being accentuated by bad ground conditions. The walls were therefore redesigned as a series of self-stable cruciform units (Fig. 14). An additional beneficial effect, due to the reduced haunching necessary, was a further reduction of possible settlement restraint upon the infill panels, thus achieving a more flexible pavement. In the swash zone above the sixth panel, the precast cruciform units were replaced by a grid of standard concrete road kerbs, bedded and haunched, and set flush.

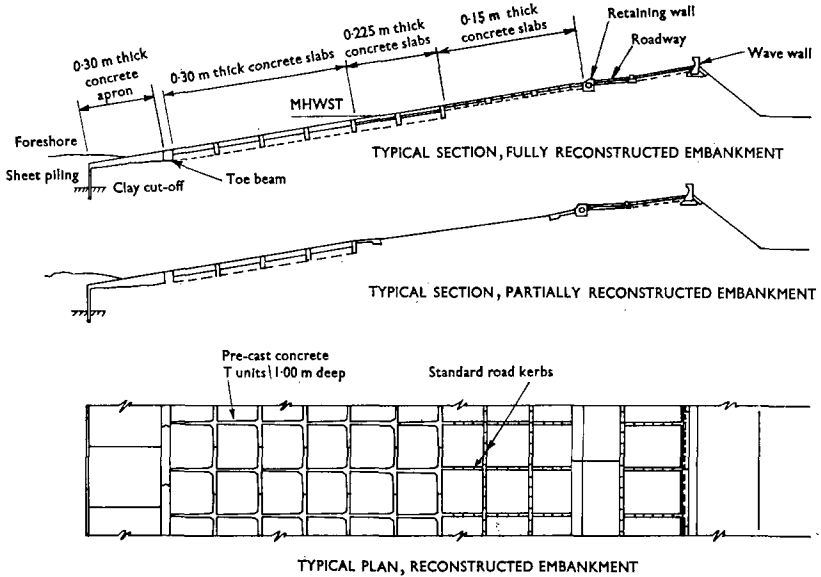
Fig. 16. Typical plan and cross-section for stage II of reconstruction

some handling difficulties were experienced with the cruciform units, both in the precast yard and on the embankment. A number of units cracked at the roots of the arms as a result of minor mishandling. To overcome this tendency it has been decided to introduce tapered arms and radiused roots for the T-units. Some lack of control of the desired surface texture of the slabbing was experienced in stage I where the ripple finish was produced by hand tamping. This aspect is under review for stage II.

52. For stage II the modified facing design, which proved successful during stage I, has been changed by using precast T units in place of the cruciform units to form the sides of the square bays (Fig. 16). This should provide an improved facility for correcting alignment errors, and virtually eliminates the need for 'specials' at the top and bottom of the replacement areas. Initially
